PRELIMINARY GEOTECHNICAL INVESTIGATION

Proposed Subdivision Development

**112 – 126 OLD WARRANDYTE ROAD
DONVALE, VICTORIA**

**20 June 2014
G2698.1 AA**

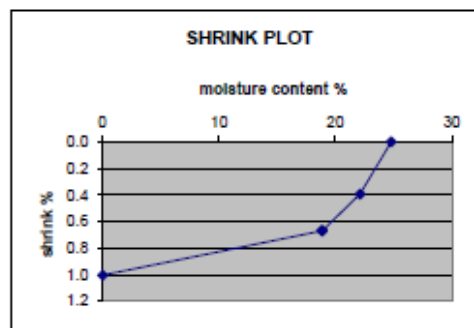
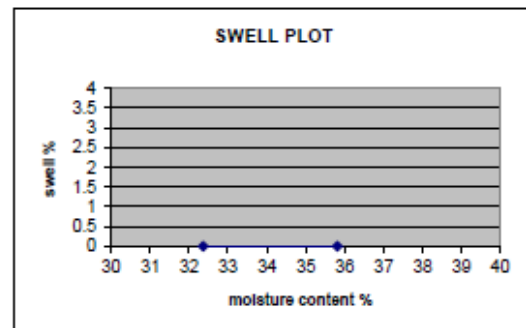
moisture content (%)		estimated UCS strength (kPa)	
before test	after test	before test	after test
32.4	35.8	75	90

swell on saturation(%)	shrink / swell index: I_{ss} (%)
0.0	0.6

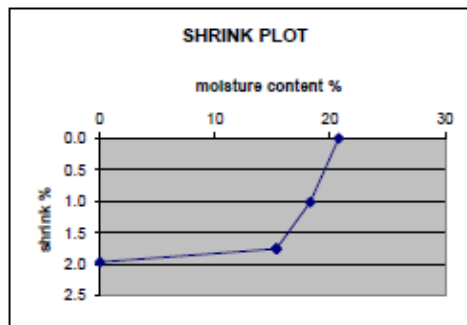
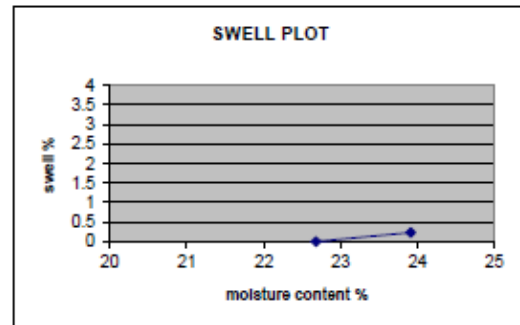
moisture content (%)		estimated UCS strength (kPa)	
before test	after test	before test	after test
22.7	23.9	145	150

swell on saturation(%)	shrink / swell index: I _{ss} (%)
0.2	1.2

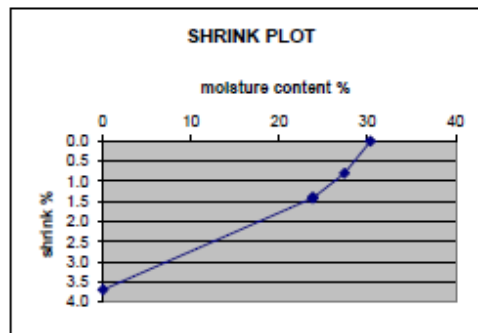
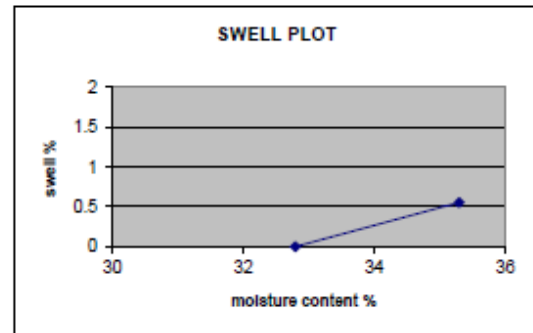
estimated inert material (%)
0.0
amount of cracking during shrinkage
high

swell on saturation(%)	shrink / swell index: I_{ss} (%)
0.6	2.2

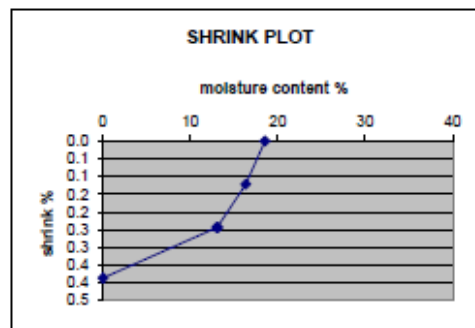
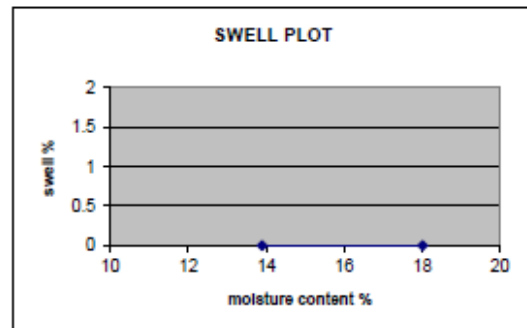
moisture content (%)		estimated UCS strength (kPa)	
before test	after test	before test	after test
13.9	18.0	275	300

swell on saturation(%)	shrink / swell index: I _{ss} (%)
0.0	0.2

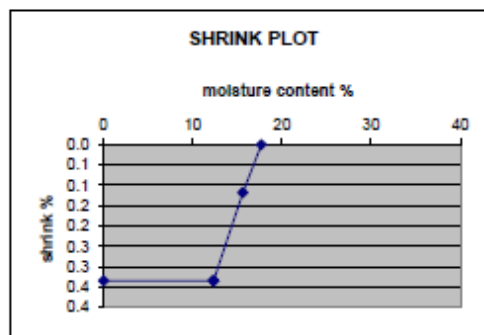
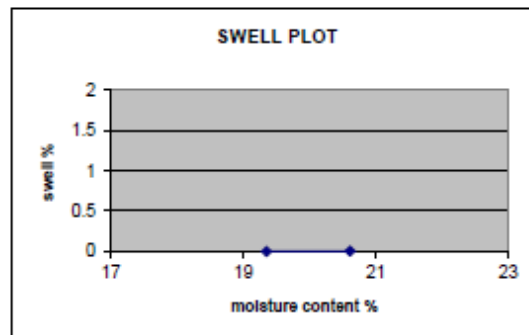
moisture content (%)		estimated UCS strength (kPa)	
before test	after test	before test	after test
19.4	20.6	165	155

swell on saturation (%)	shrink / swell index: I_{ss} (%)
0.0	0.2
